Alan Jaskot¹, Jacek Pierzak², Krzysztof Rak³

Czeladź city gate and walls in light of archaeological research

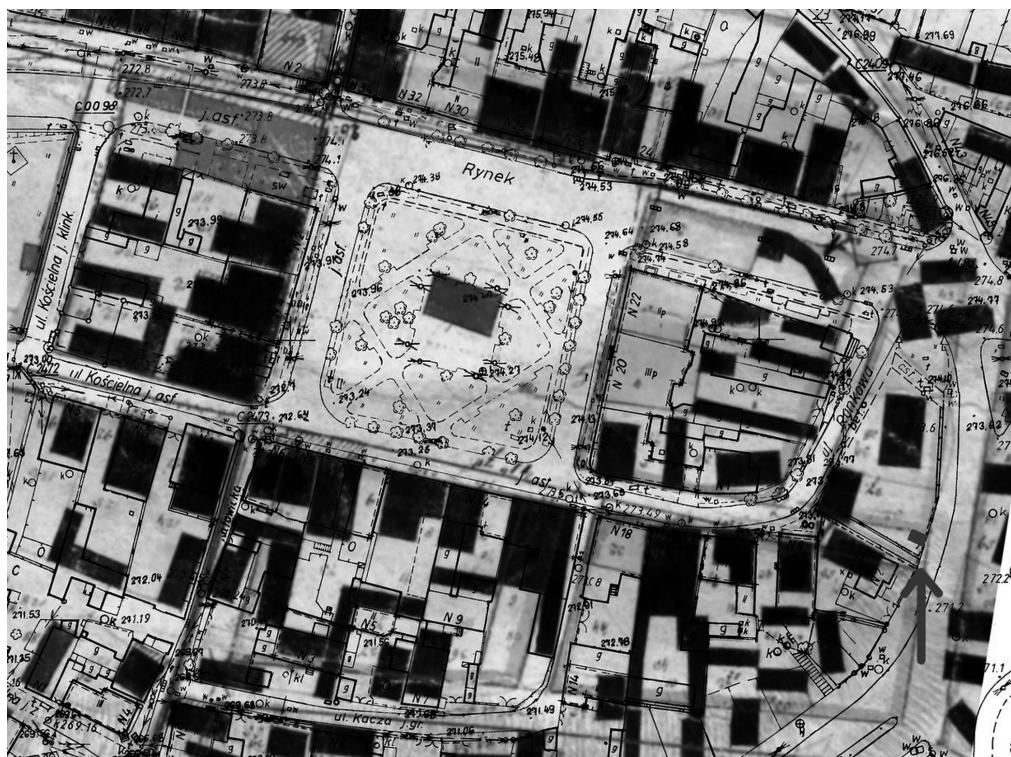
Fig. 2. Location of archaeological survey trenches on the map of Czeladź centre

In 2016, the authors of this article performed an archaeological survey less than 70 metres east of the Market Square (Fig. 2). A 5×3 m excavation trench was established, oriented on the east-west axis. The exploration resulted in the discovery of copings of two walls.

The above arguments and the fact that the walls are located on the axis of Rynkowa Street, which leads to the Market Square, are enough to establish that these wall remains are remnants of city fortifications, namely of a city wall and of the eastern city gate, which led to Będzin, and further to Cracow (Fig. 2). The opening of the presumed gate lies on the same axis as the exit from Rynkowa Street.

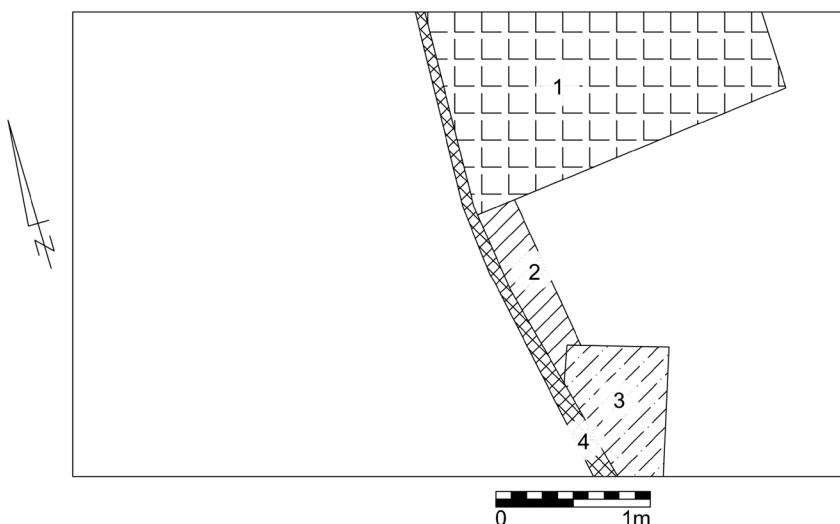
Fig. 3. Plan of the 2016 excavation trench. 1 – remains of the city gate, 2 – remains of the defensive wall,
3 – modern well drainage, 4 – modern sewage pipe

Remains of the first of these two walls were made of stone (Fig. 3). The wall was oriented along the north-west – south-east axis, and was interpreted as a fragment of a city wall. Its width was 1.40 m. As only a single layer of stone survived, it was not possible to determine the bond used in its construction (Fig. 4). The wall was built using stones of various sizes, hewn only on the face side. The wall was added to another wall (Fig. 5), 0.60 m wide at the foundation; however, this wall was sunk into a compact layer of marl and clay, which reinforced it from the inner side. It is highly probable that the above-ground part of the wall was of the same width as the segment discovered on the outer side of the church.

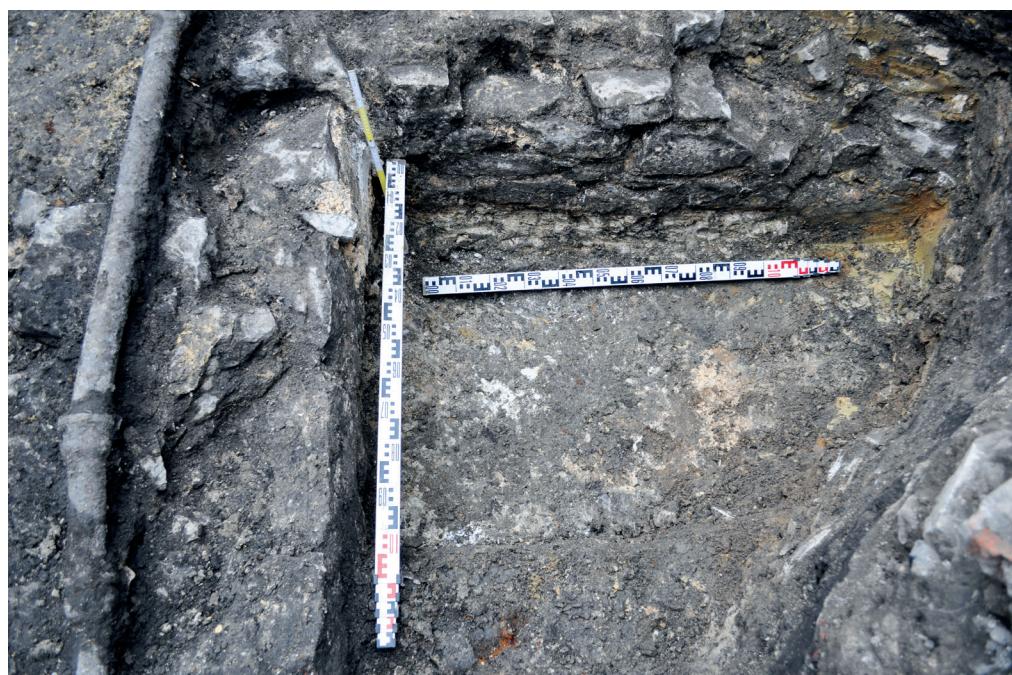
Fig. 5. Remains of the city gate (up), and remains of the defensive wall (left)

The second discovered wall remains were also made of stone. The wall was oriented on the south-east – north-west axis. It was over 0.80 m wide, 2.07 m long and was preserved up to a height of 0.47 m. Five stone layers survived. These remains were interpreted as the southern part of the eastern city gate. They were destroyed in the eastern part of the survey site by a cut made most likely in the 16th century. Two fragments of earthenware were discovered in the fill of this cut, dated to, respectively, between the 15th/16th centuries and the 16th century. This material allows the *post quem* date of the cut to be determined as the 16th century.
